DEPARTMENT OF TRANSPORTATION

Contract #: 04-0120F4Cty: SF/ALA Rte: 80 PM: 13.2/13.9File #: 69.28**WELDING INSPECTION REPORT****Resident Engineer:** Siegenthaler, Peter**Address:** 333 Burma Road**City:** Oakland, CA 94607**Report No:** WIR-021453**Date Inspected:** 03-Feb-2011**Project Name:** SAS Superstructure**OSM Arrival Time:** 700**Prime Contractor:** American Bridge/Fluor Enterprises, a JV**OSM Departure Time:** 1500**Contractor:** Zhenhua Port Machinery Company, Ltd (ZPMC), Changxing Island **Location:** Shanghai, China

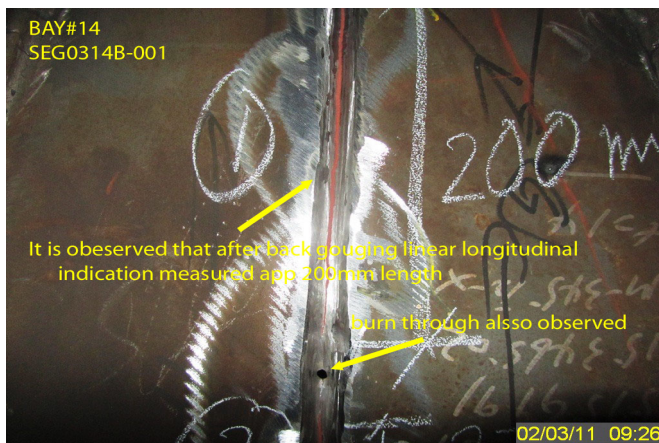
During the Quality Assurance random visual inspection of welds located on Floor beam, deck panel diaphragm welds of OBG Segment 13BW, this Quality Assurance Inspector (QA) observed the following issues;

- Linear Longitudinal Indications measuring approximately 200mm in lengths and punctured/burn through.
- After back gouging, these indications were discovered visually and confirmed by Magnetic particle Testing (MT) by ZPMC MT personnel.
- The indications are clearly marked on the material near the weld for further repair. The weld number is identified as SEG3014B-001. The panel point is identified as a PP122.
- This weld is a CJP weld joining the Deck Panel Diaphragm to Deck Panel Diaphragm.
- The Deck Panel Diaphragm to Deck Panel Diaphragm weld is identified as Seismic Performance Critical Member (SPCM).
- The cracks are completely removed and re-weld shall be performed as per required contract document and approved WPS. For further information, Please see attached pictures.

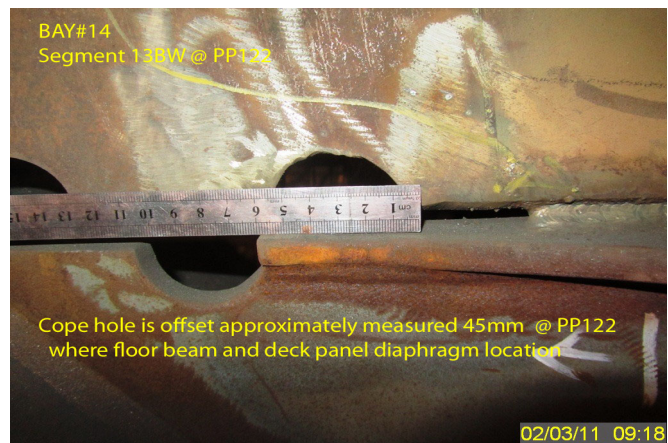
During the Quality Assurance random visual inspection of welds located on Floor Beam at panel point 122 bike path side of Segment 13BW, this Quality Assurance Inspector (QA) observed the following issues;

- Offset in a cope hole located at Floor beam to Deck Panel Diaphragm.
- The offset is measured approximately 45mm in length.
- The floor beam number is identified as FB3204A and Deck Panel is identified as DP3137A.
- Floor Beam and Deck Panel Diaphragm are identified as Seismic Performance Critical Member (SPCM). OBG
- Segment 13BW is located West Side of Bay 14 area.
- According to the contract document ZPMC personnel need to submit Critical Weld Repair to the engineer prior to weld repair. For further information, Please see the attached pictures.
